**CDC NCEH Environmental Health Services Support
for Public Drinking Water Programs to Reduce
Drinking Water Exposures Grant Project
6/26/18 Presentation to NEHA**

**Reducing Drinking Water Exposures Through
Individual Well Assessments & Outreach**

Madison County Health Department
Environmental Health Division
Madison County, New York

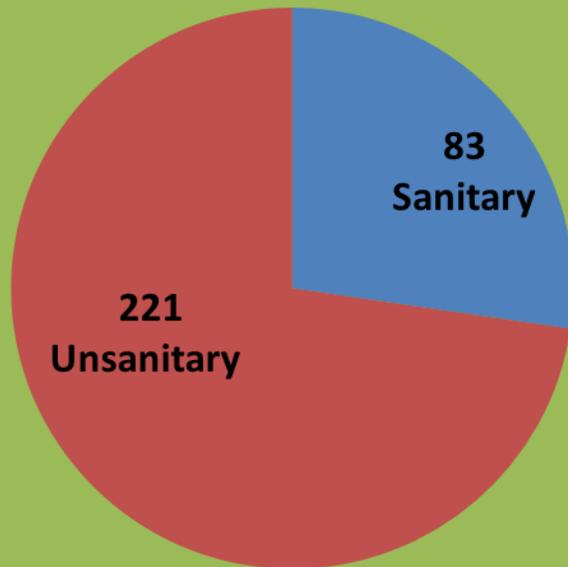
304 Tested Drilled Wells

Bacteriological test results of drilled wells with unsanitary well caps or sanitary well caps

- **38%** of drilled wells tested in Madison County from 9/30/15-4/30/18 were positive for total coliform bacteria. The presence of total coliform bacteria is an indication of susceptibility to contamination.
- A well with a sanitary cap was found to be **67%** less likely to be contaminated by bacteria than a well with an unsanitary cap.
- A proper sanitary well cap and additional source protection measures can help protect well water from bacteriological contamination.

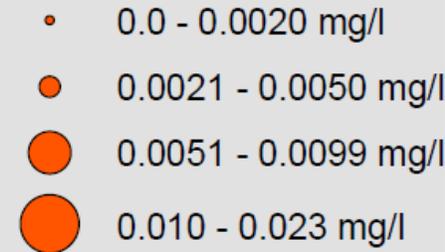
Arsenic Hotspot

Arsenic

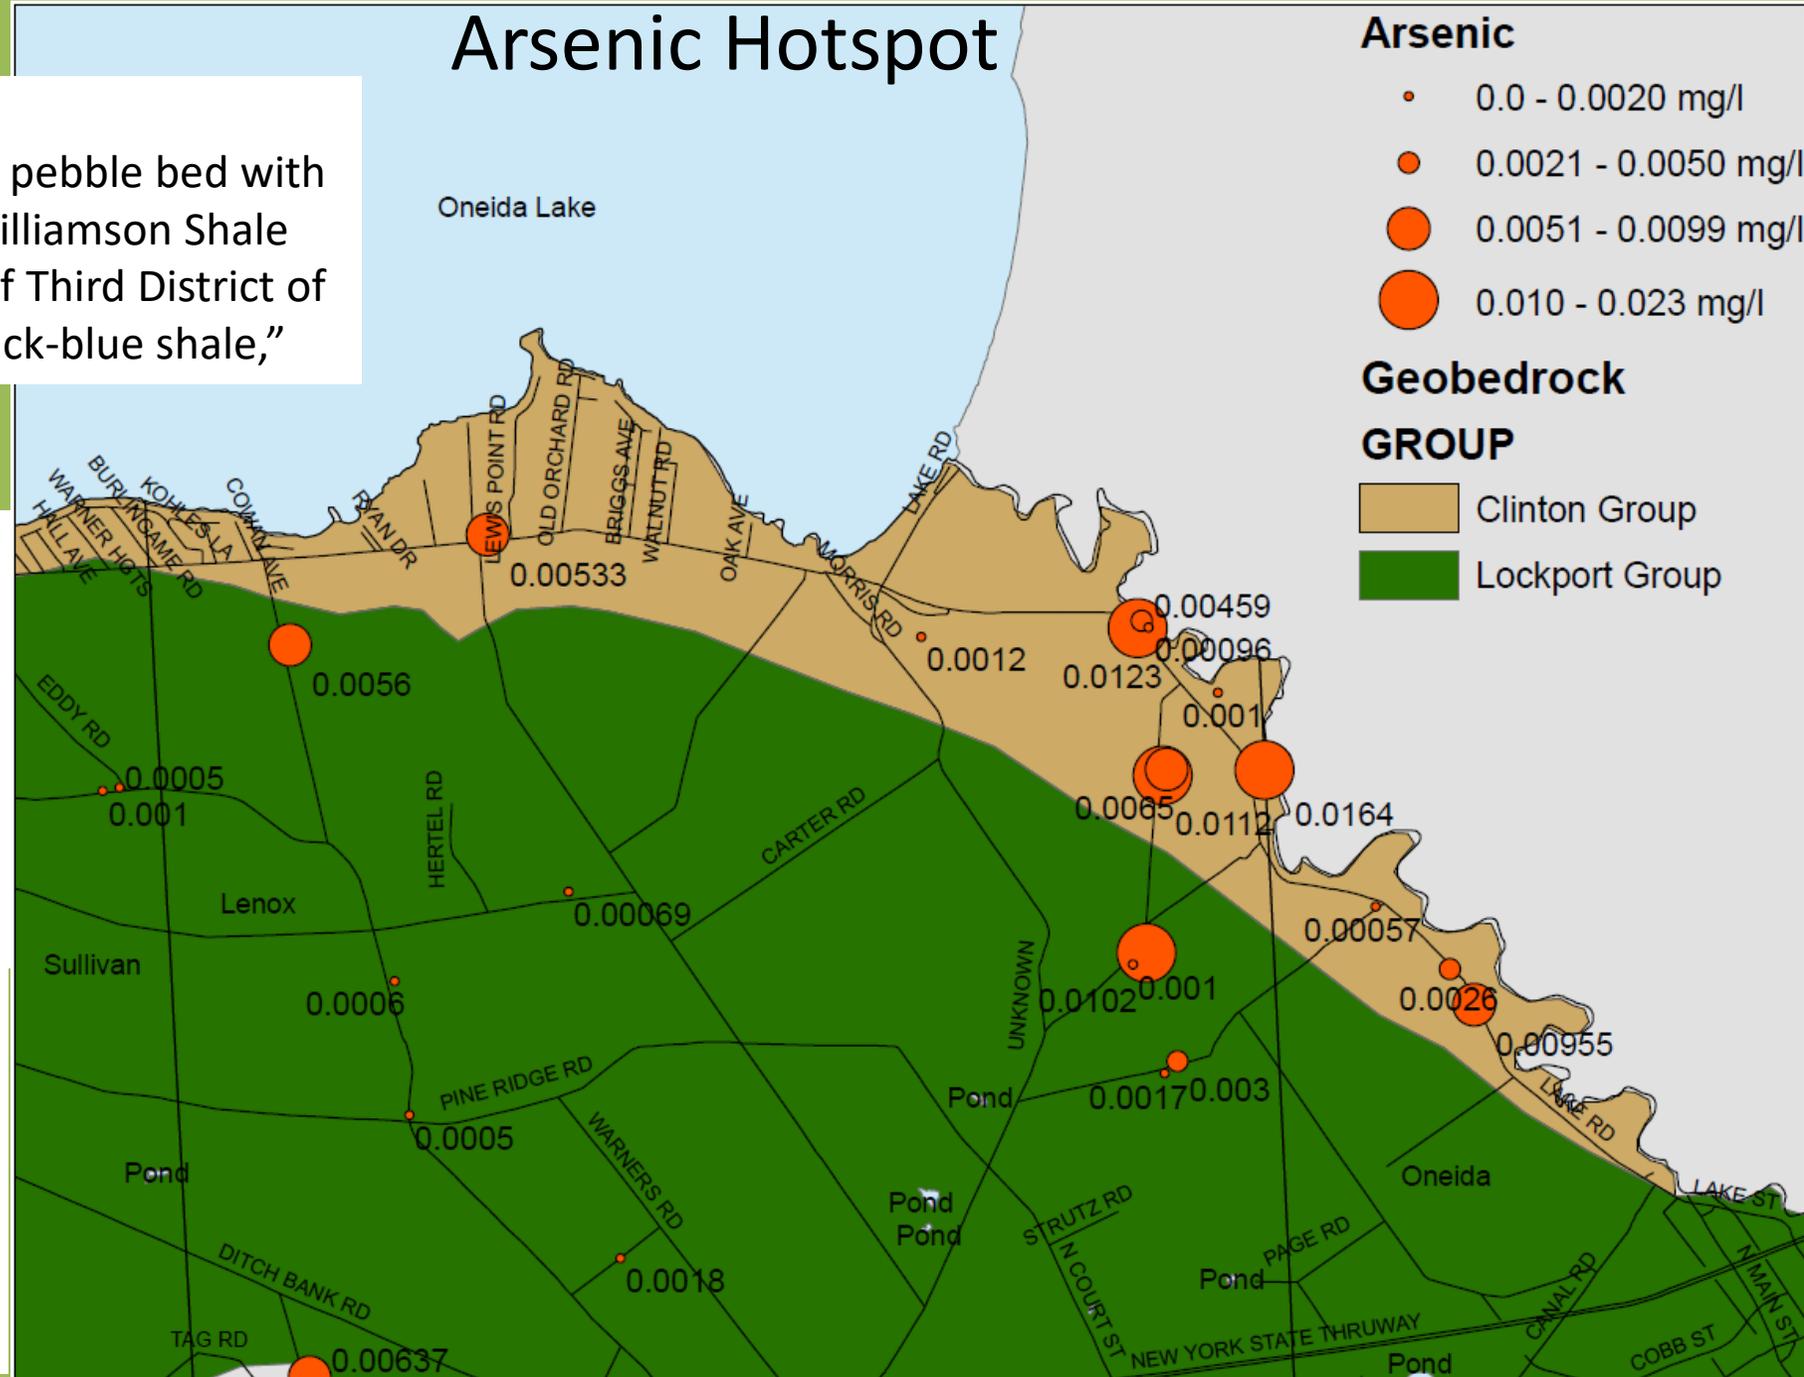
Geobedrock GROUP

Clinton Group Comments

“a new name for a phosphatic quartz pebble bed with abundant pyrite at the base of the Williamson Shale (Lin and Brett, 1988). Clinton group of Third District of NY defined. Consists of green and black-blue shale,”

Well log within the arsenic hotspot

6" well 80' deep
 68'7" of 6" casing with drive shoe
 20' of 4.5" pvc .020 slot screen
 1 gallon per minute
 14' static water level

Formations:

- 0-6' sandy loam
- 6-40' clay & stone
- 40-41' loose gravel & sand
- 41-64' clay, silt & stone
- 64-71' gravel, sand & clay balls
- 71-81' green shale

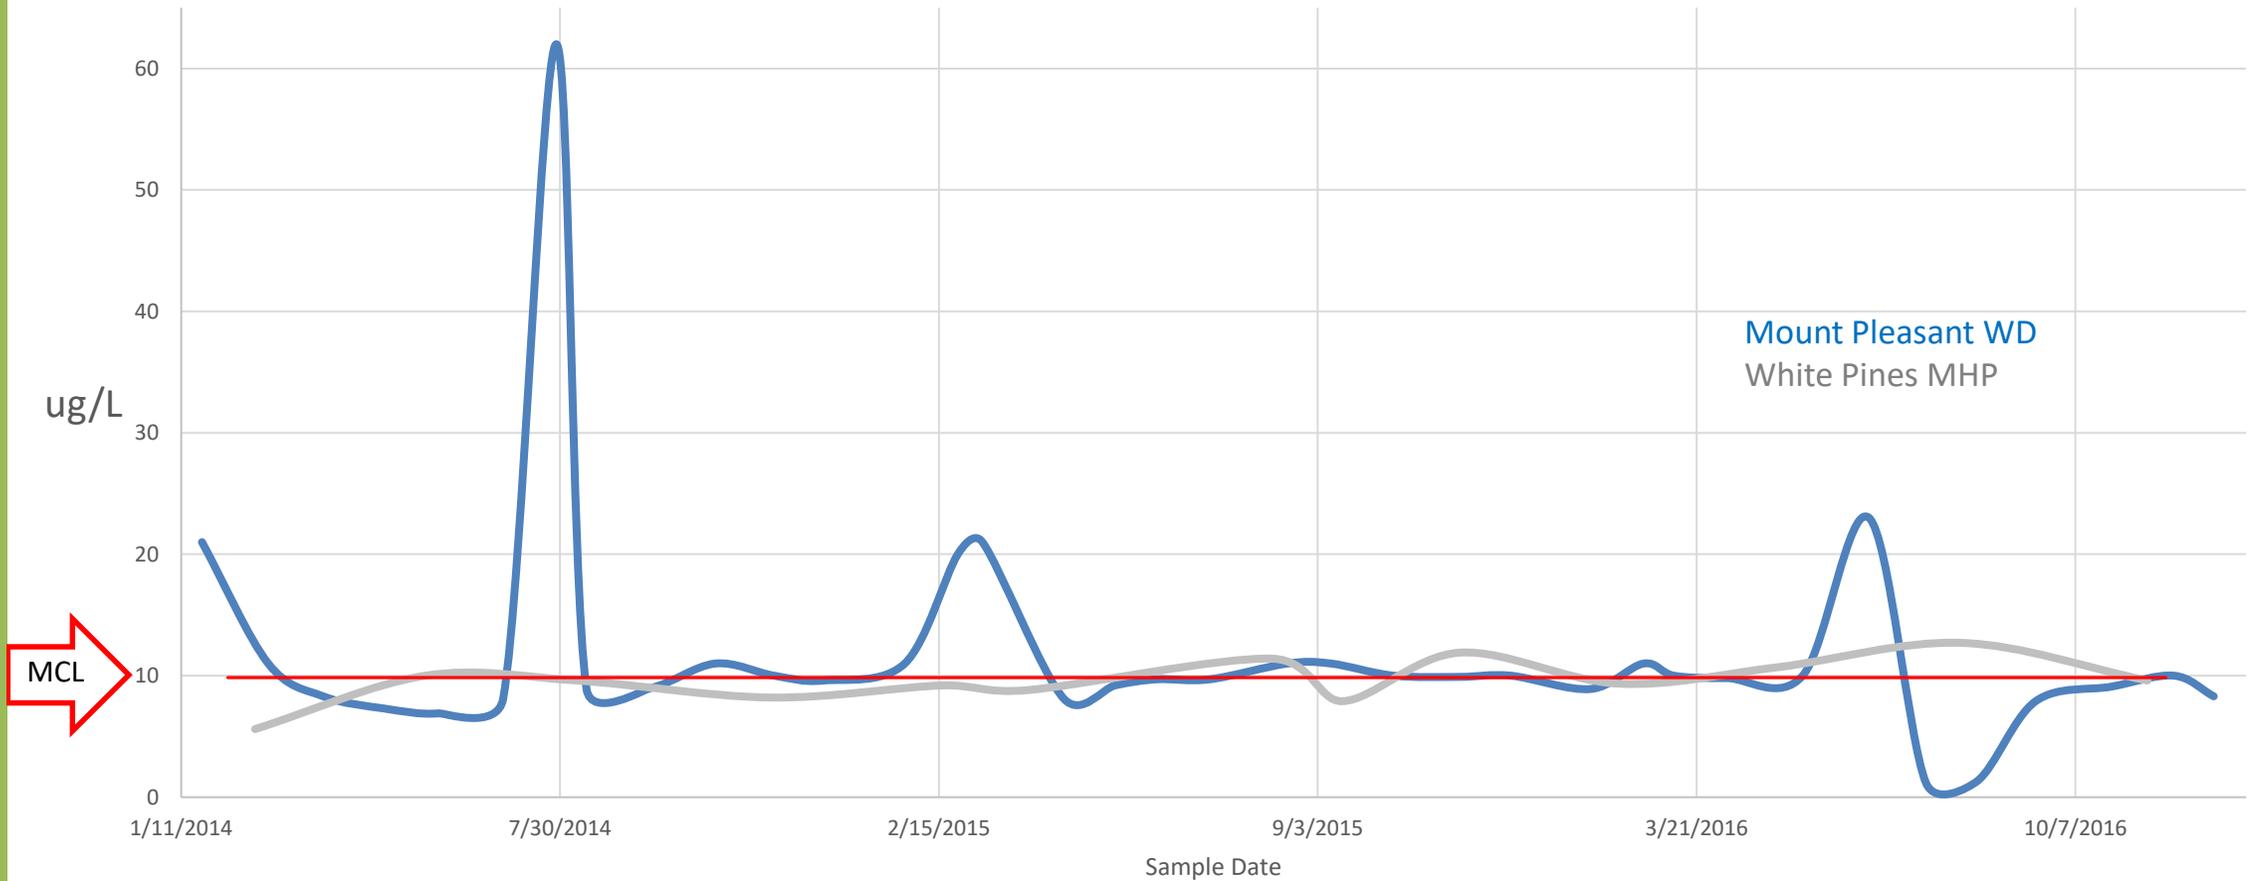
Arsenic Levels Over Time

Testing done by the Madison County Department of Health has shown arsenic levels in groundwater over time to be highly varied.

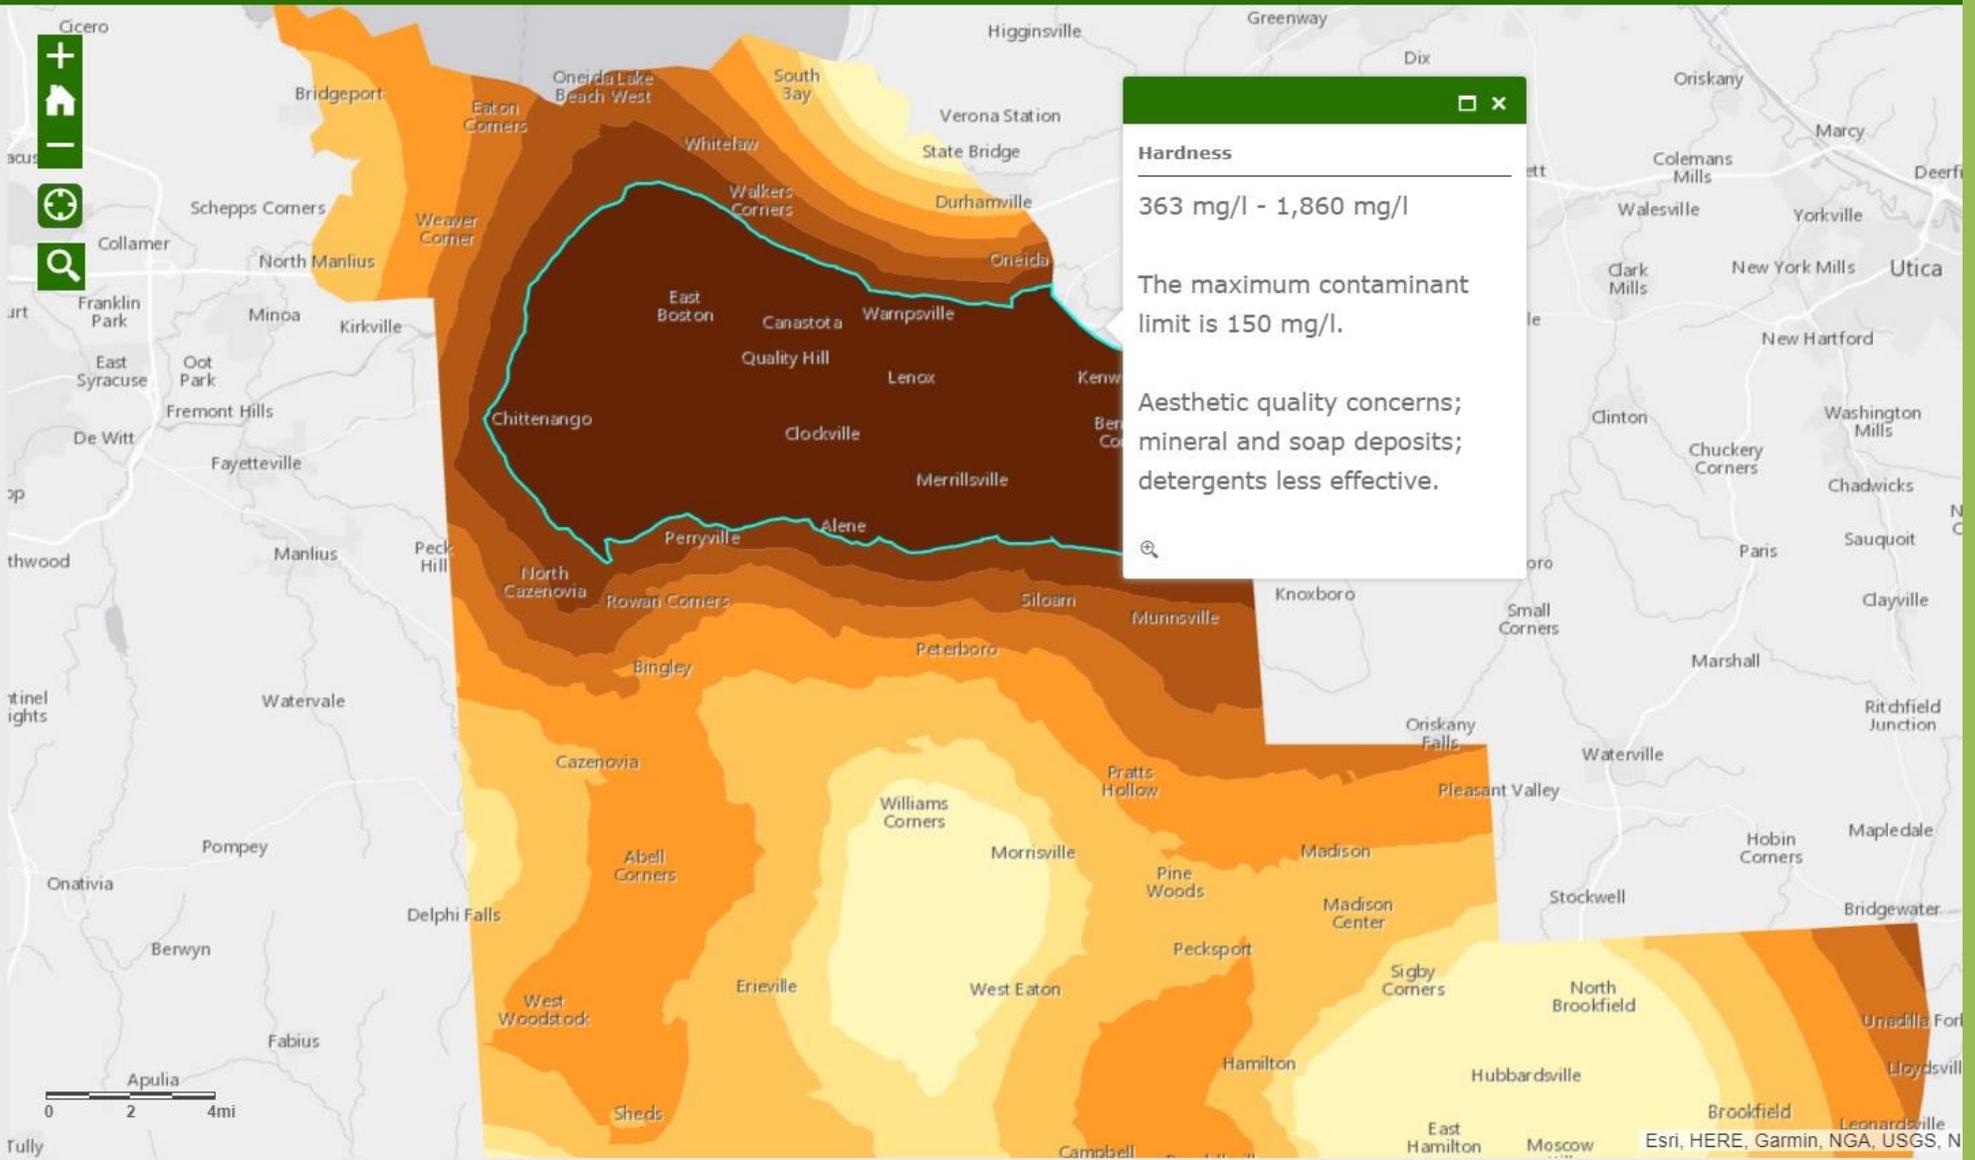
Hardness

- 56-87 mg/l
- 87-139 mg/l
- 139-155 mg/l
- 155-192 mg/l
- 192-226 mg/l
- 226-260 mg/l
- 260-307 mg/l
- 307-363 mg/l
- 363-1860 mg/l

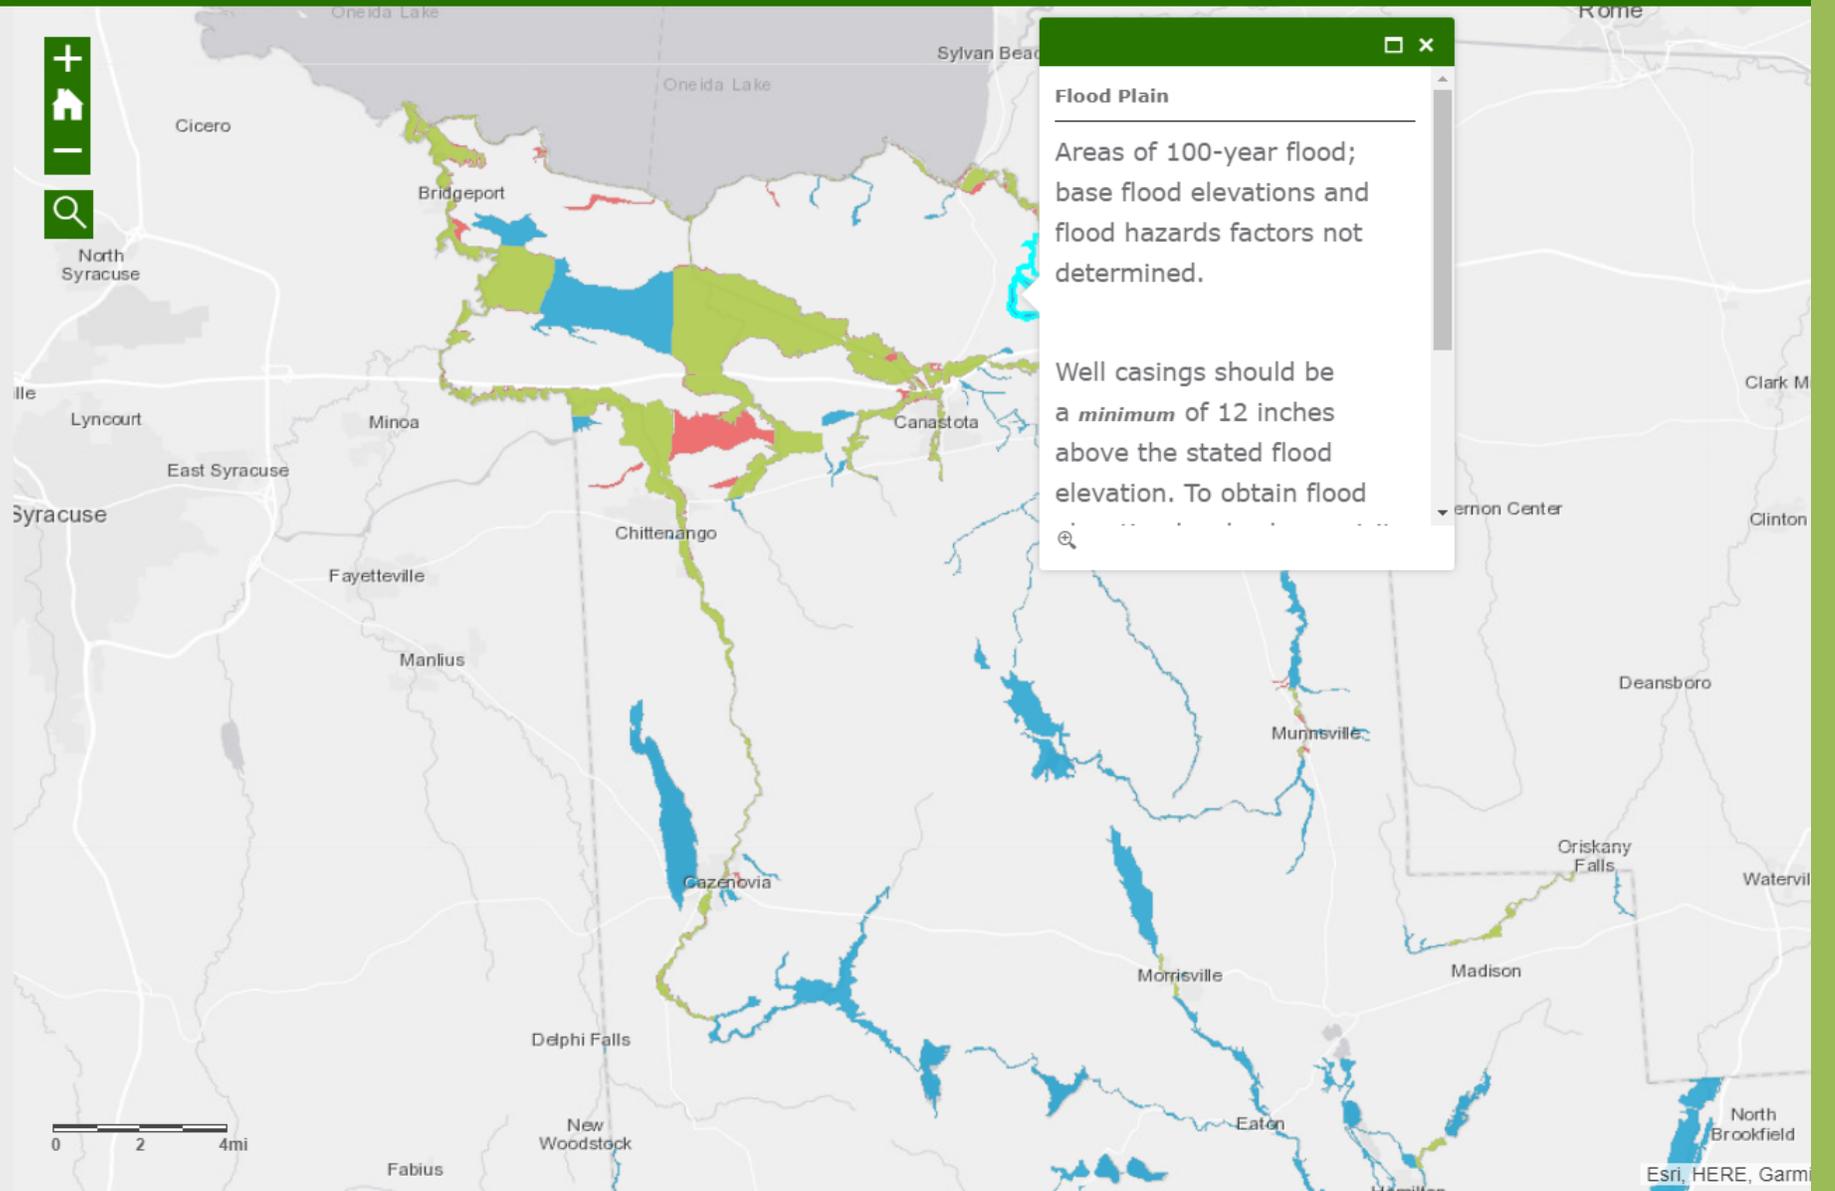
Flood Plain

Areas between limits of the 100-year flood and 500-year flood; or certain areas subject to 100-year flooding with average depths less than one (1) foot or where the contributing area is less than one square mile; or areas protected by levees from the basin

Areas of 100-year flood; base flood elevations and flood hazards factors not determined.

Areas of 100-year flood; base flood elevations and flood hazard factors determined.

Areas of 100-year shallow flooding where depths are between one (1) and three (3) feet; average depths of inundation are shown, but no flood hazard factors are determined.

Well casings should be a *minimum* of 12 inches above the stated flood elevation. To obtain flood

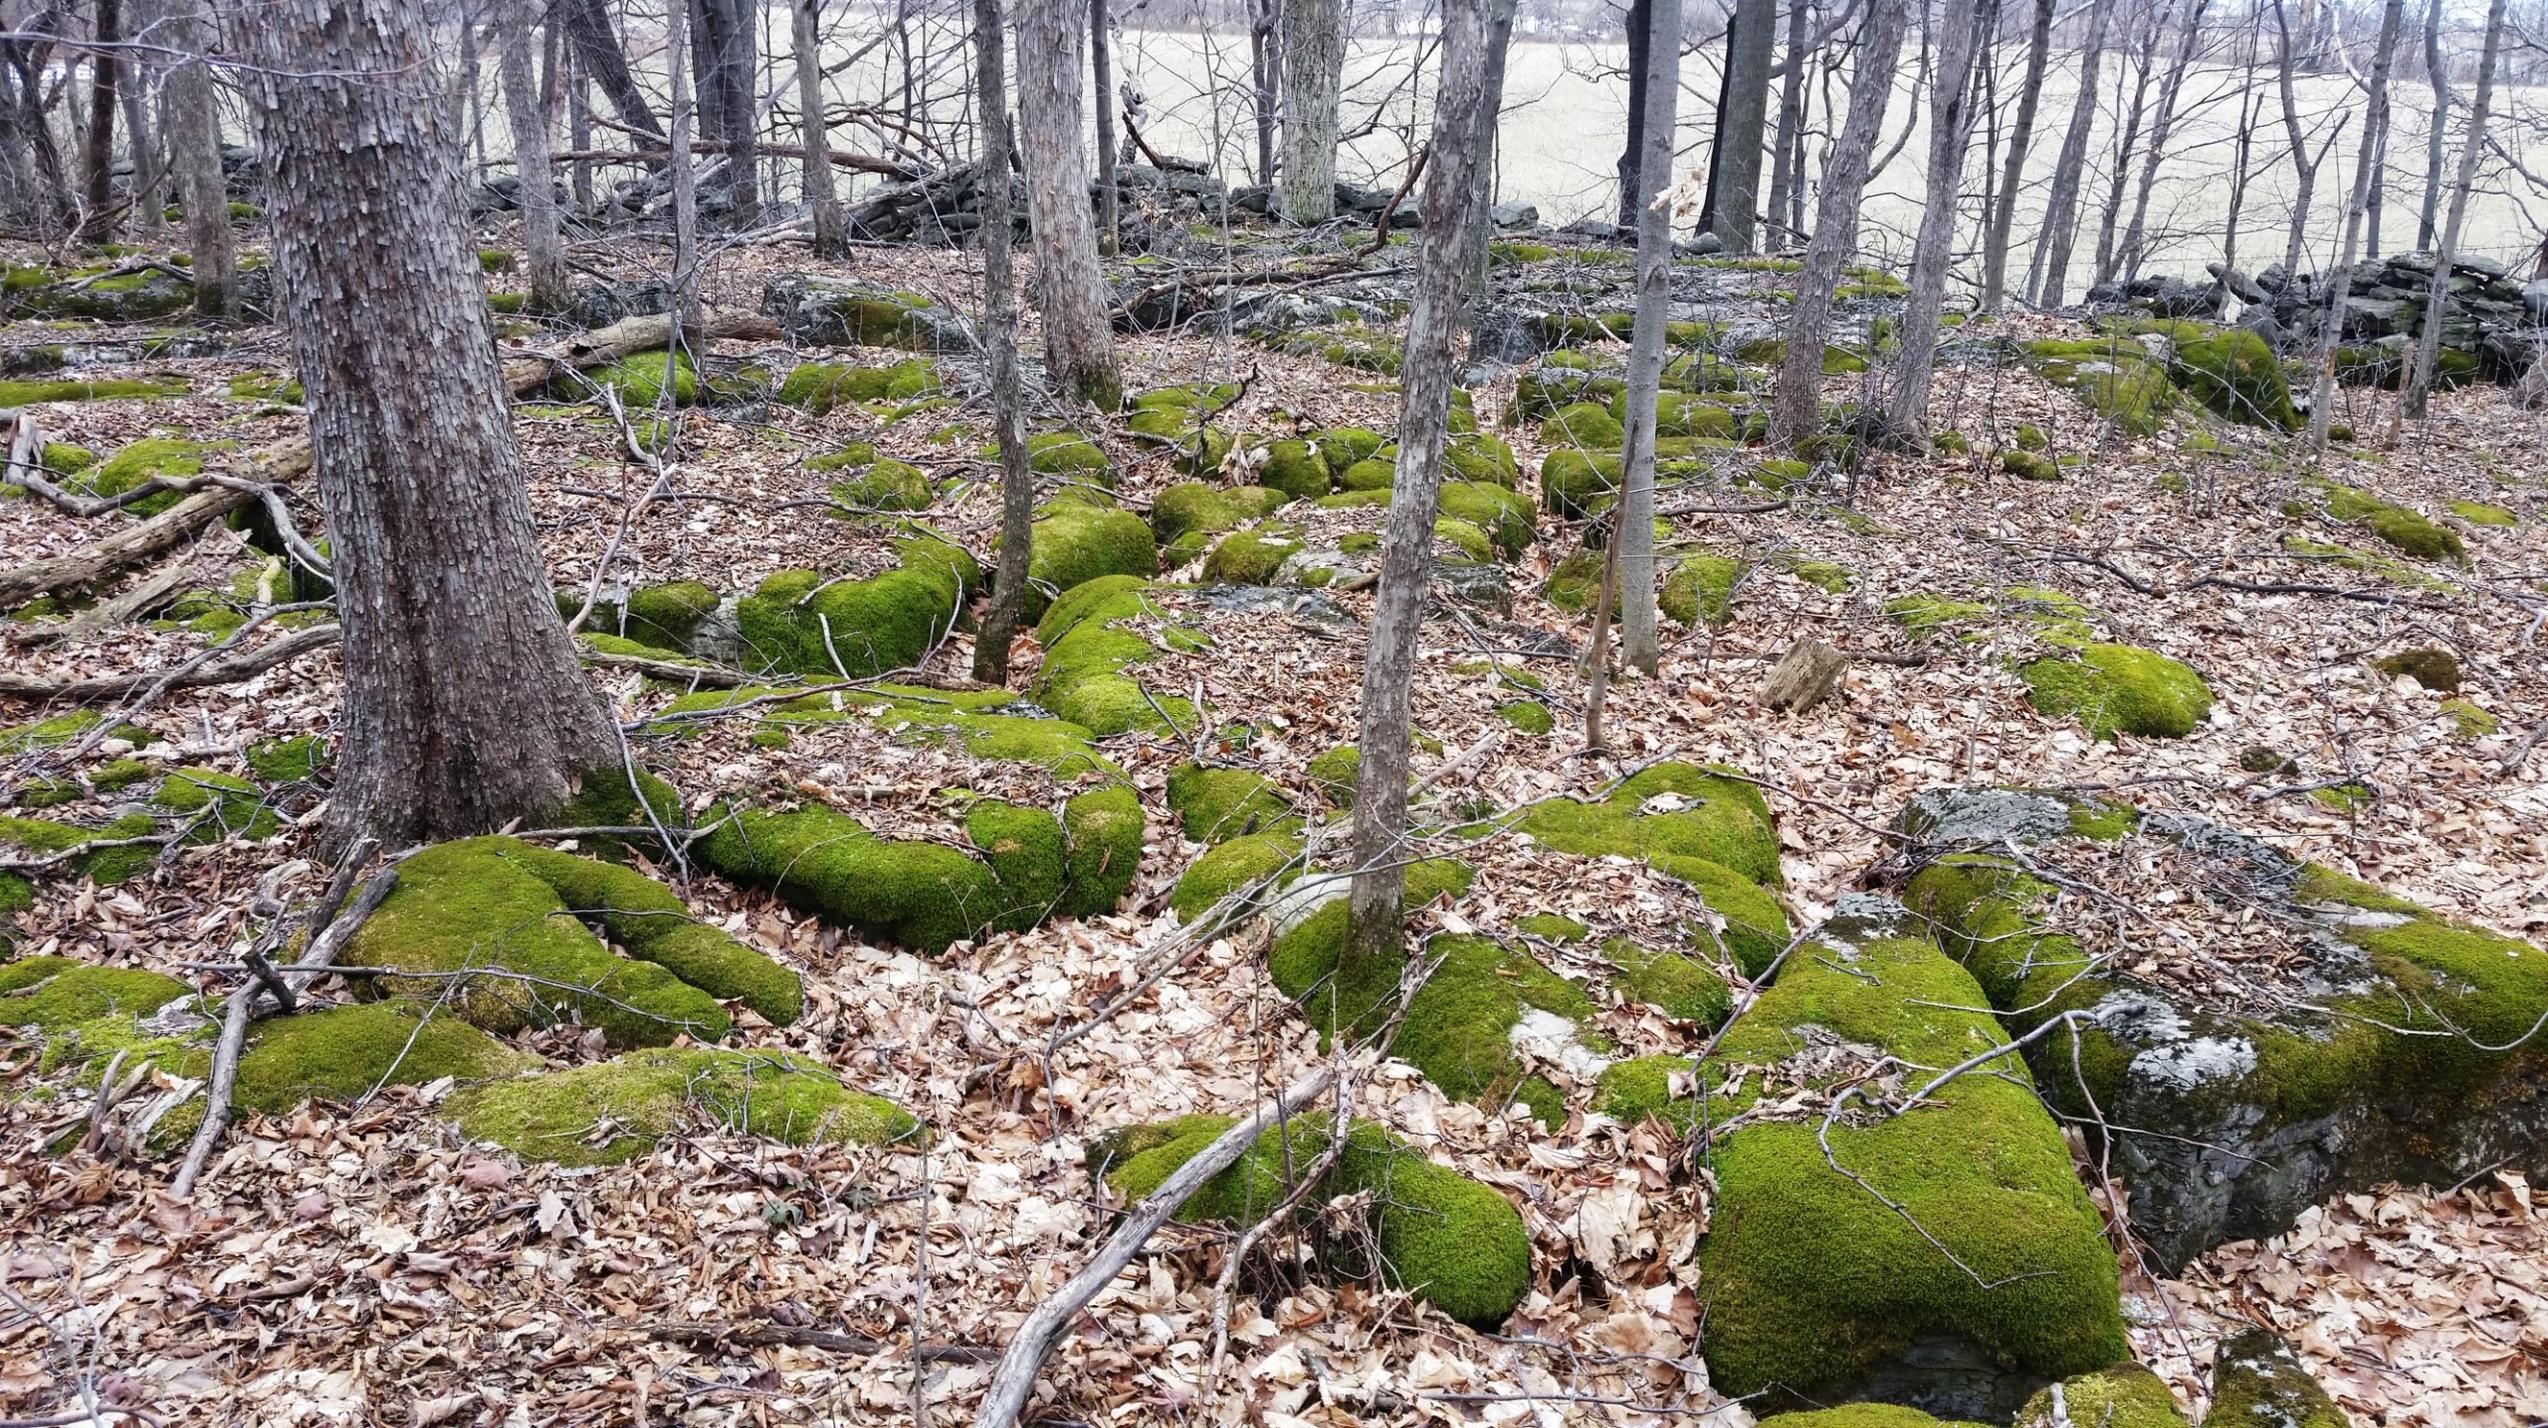
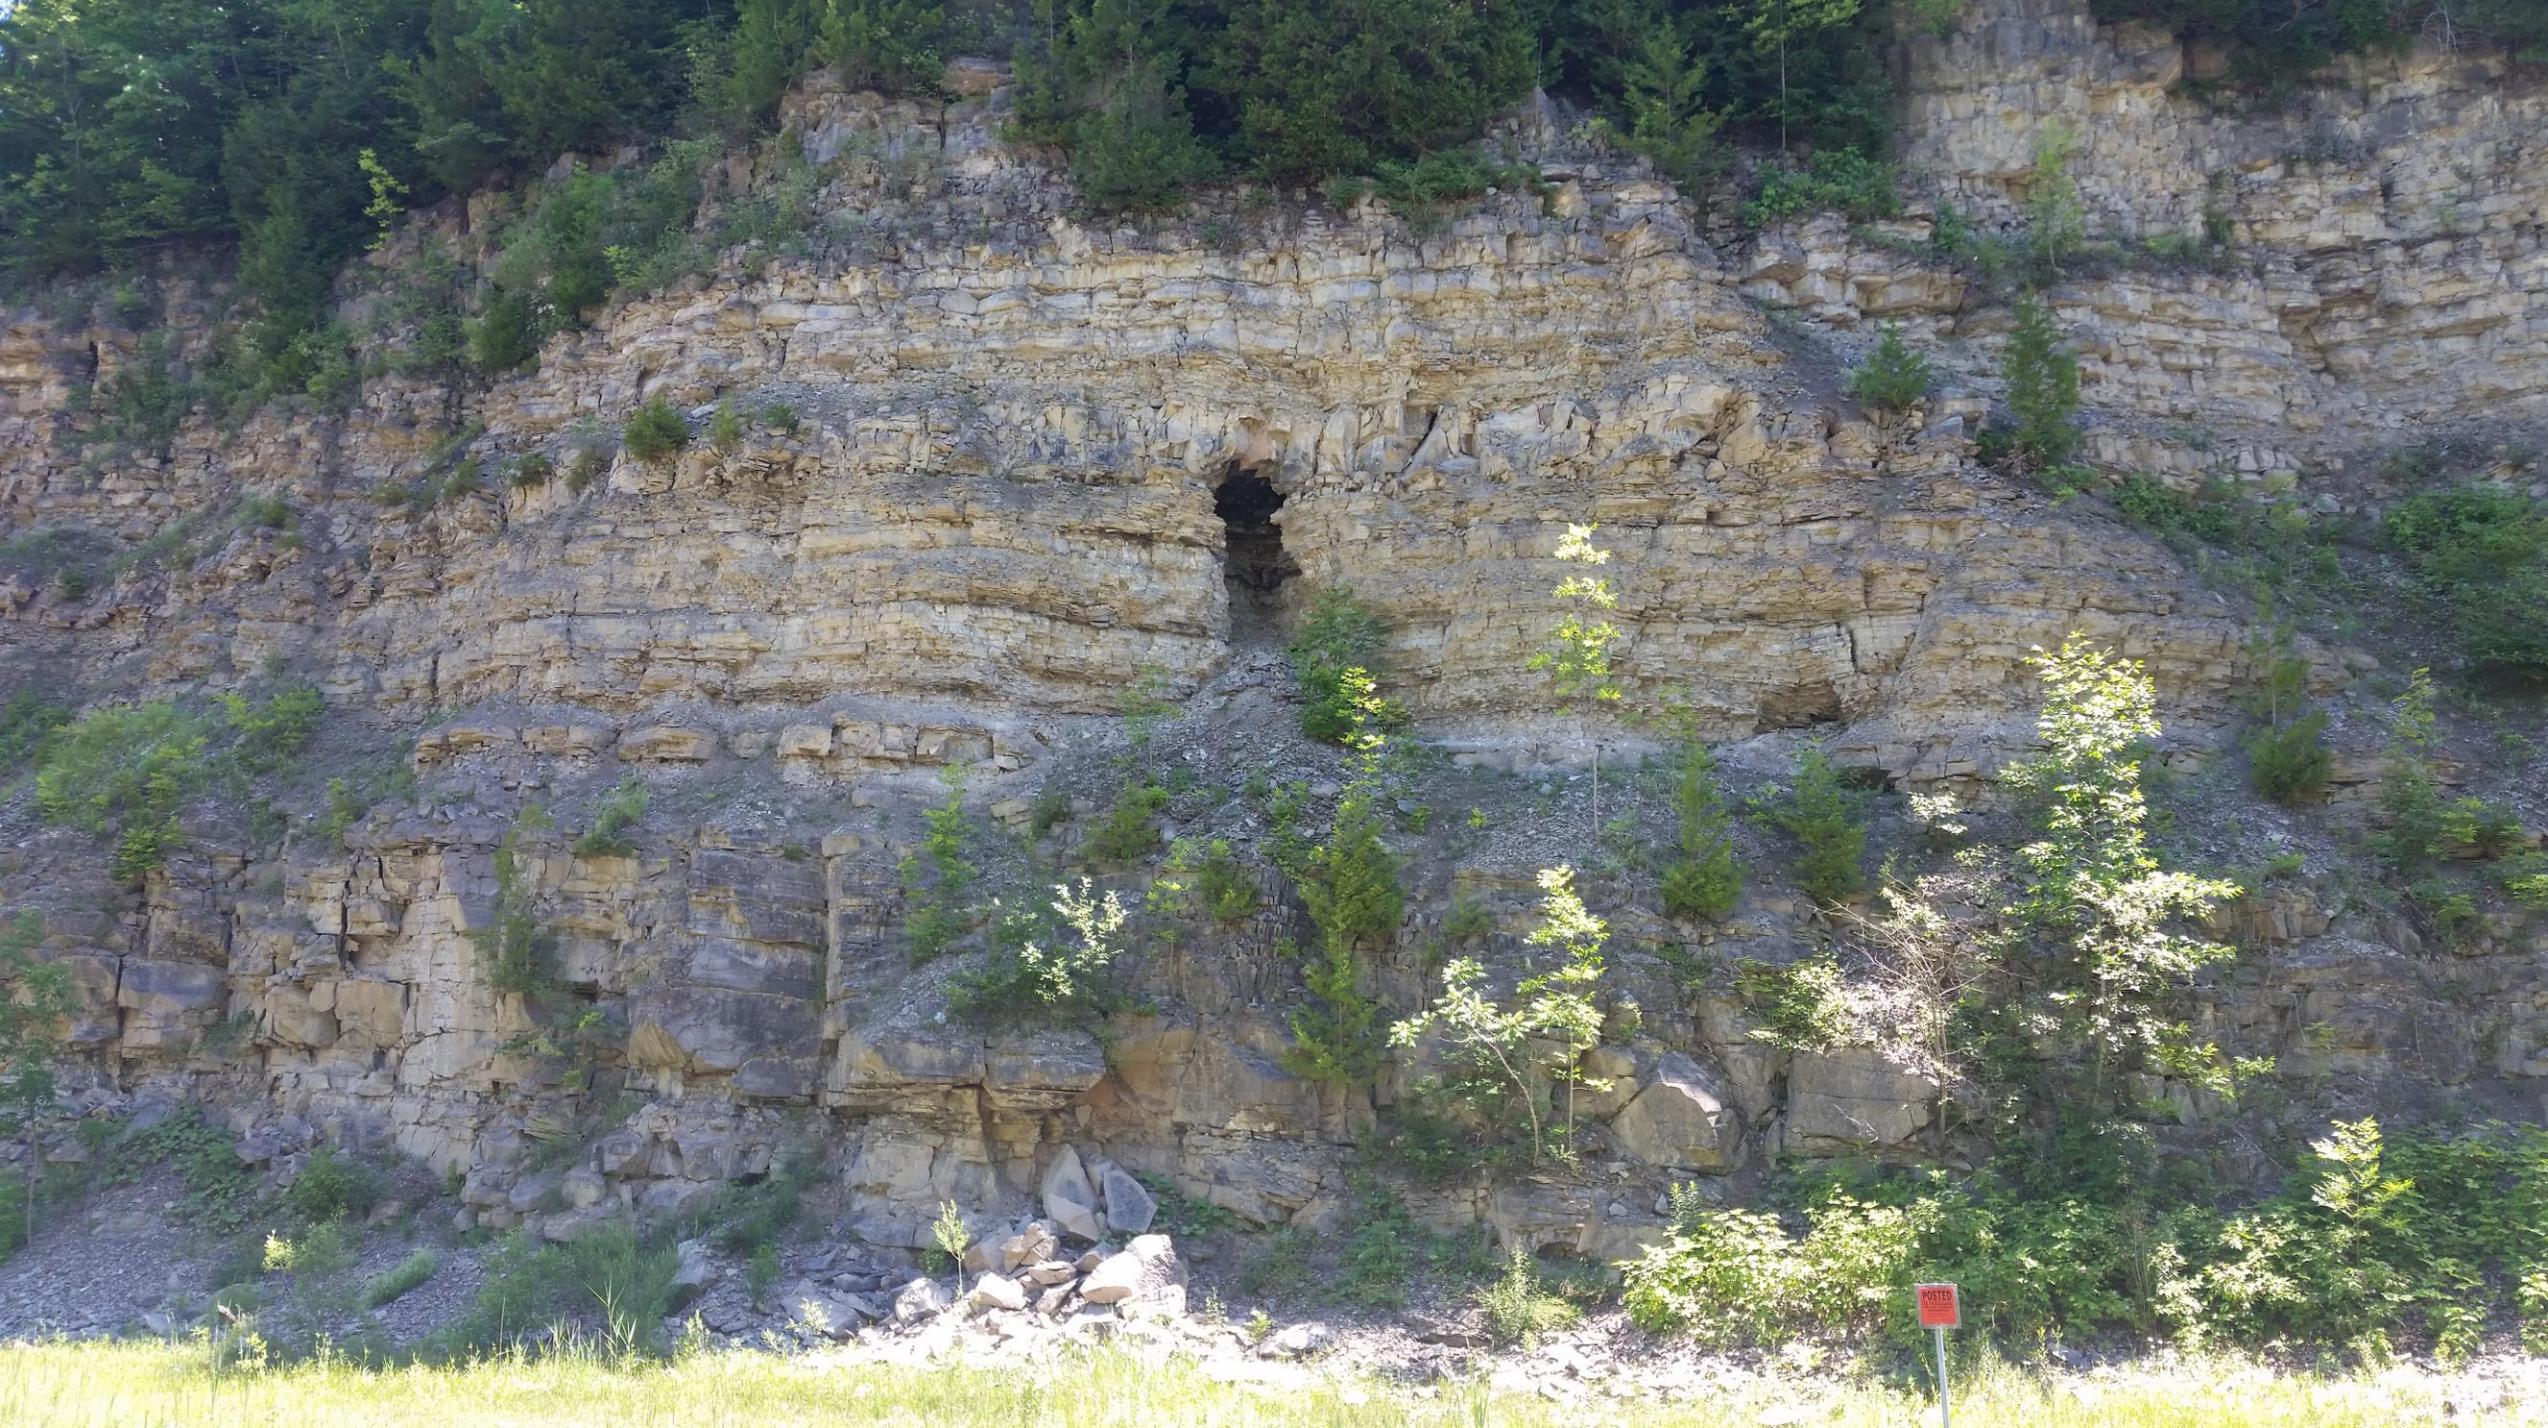
Karst Topography in Madison

Karst topography is characterized by the dissolution of soluble rocks which results in underground drainage. It is known to create rapid water flow with a lack of a natural filtration system. This can increase ground water contamination as contaminants flow quickly and undetected through the underground drainage. Private wells located on top of the karst topography should be monitored regularly for they are at a greater risk of contamination.

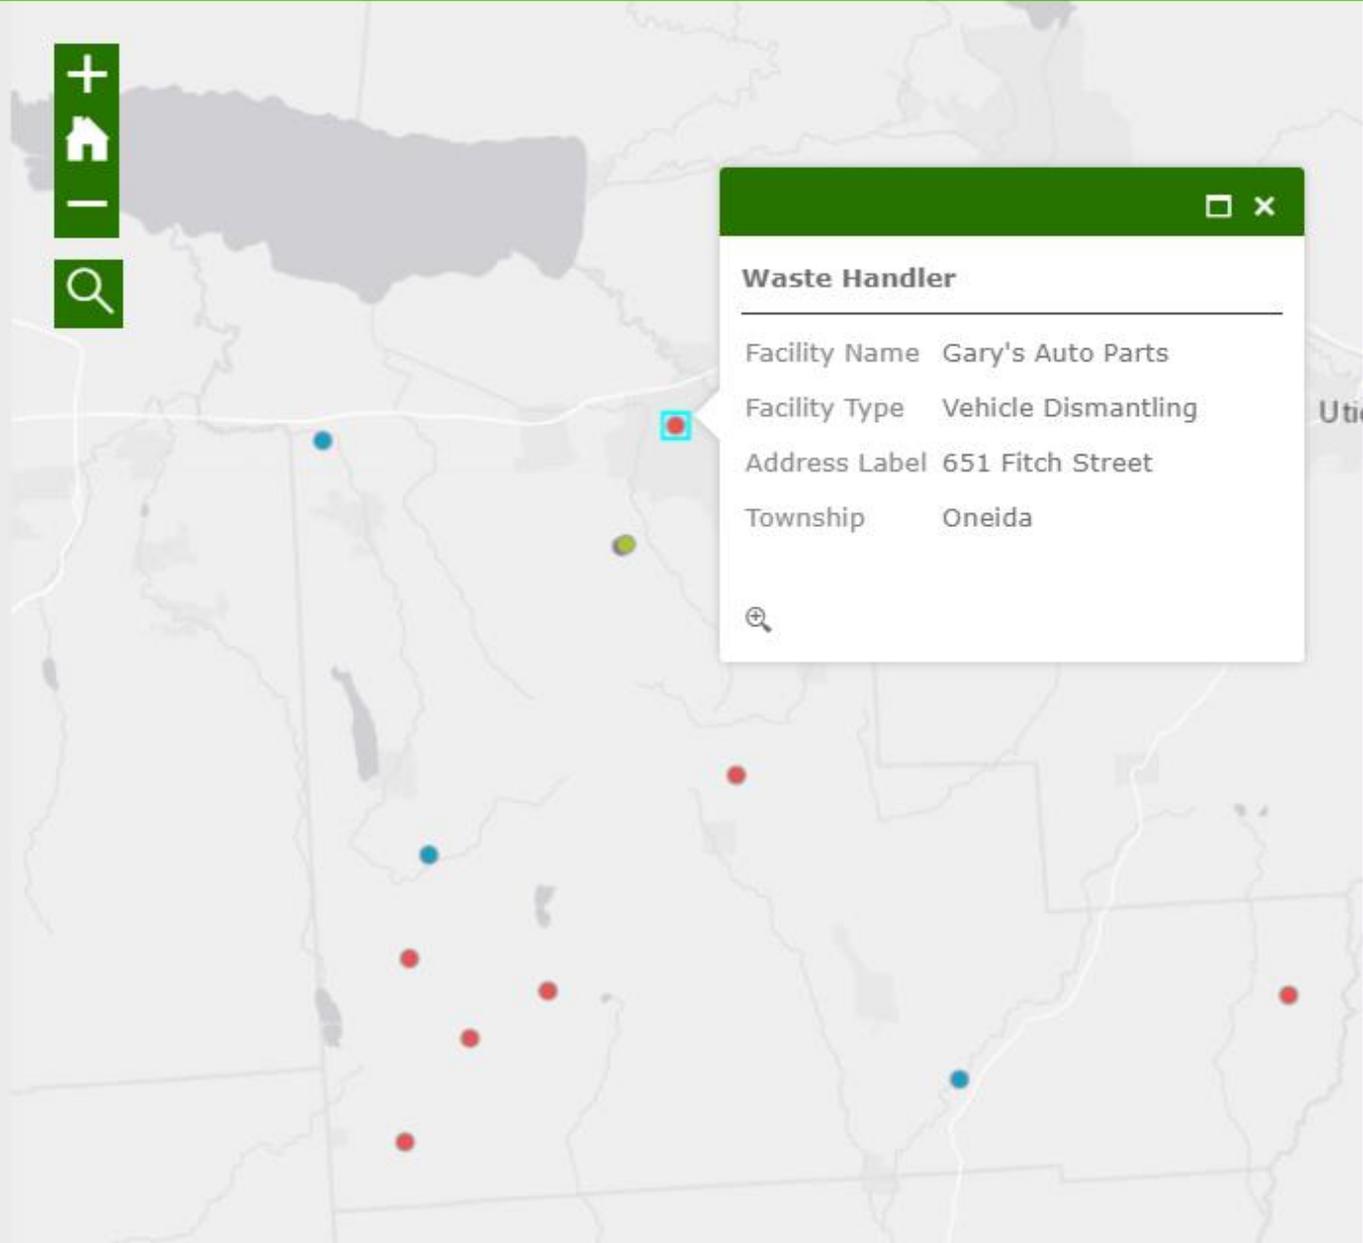
Waste Handlers

- Vehicle Dismantling
- Transfer Station
- Landfill
- Recycling Facility

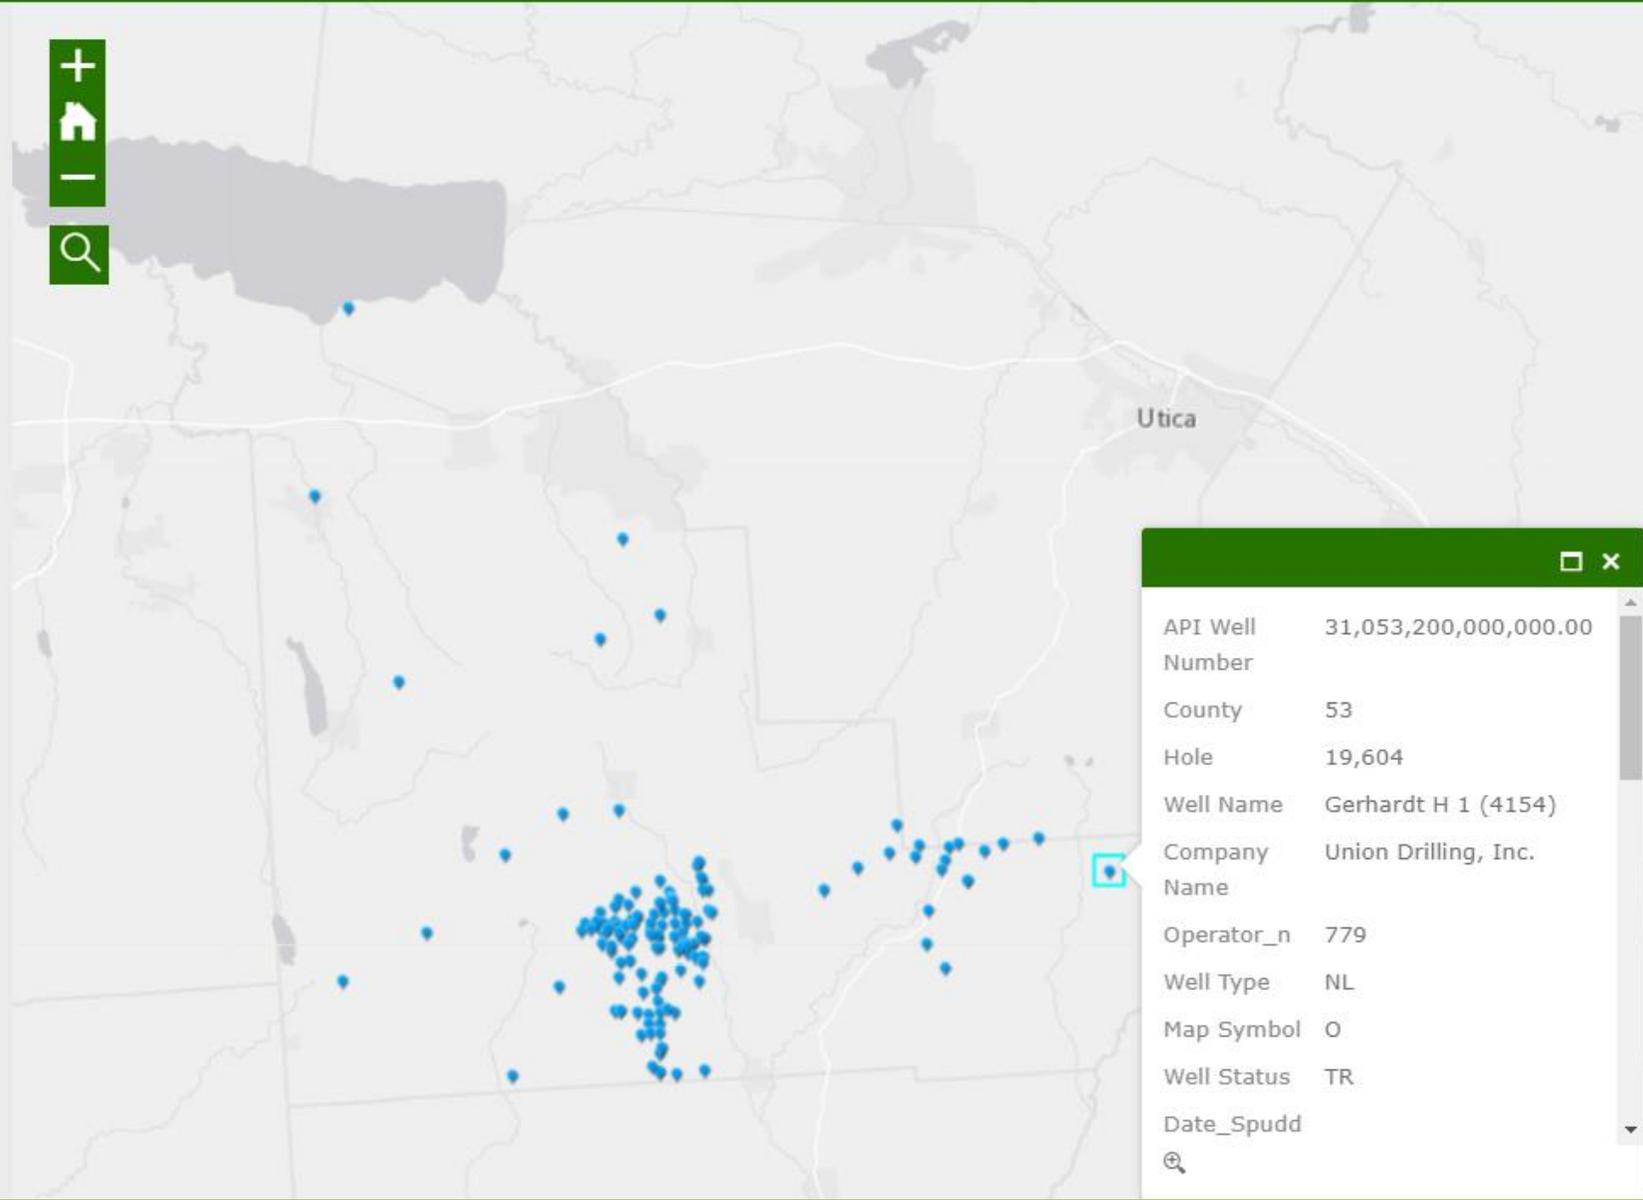
Petroleum Wells

Well Details	
API Well Number	31,053,200,000,000.00
County	53
Hole	19,604
Well Name	Gerhardt H 1 (4154)
Company Name	Union Drilling, Inc.
Operator_n	779
Well Type	NL
Map Symbol	O
Well Status	TR
Date_Spudd

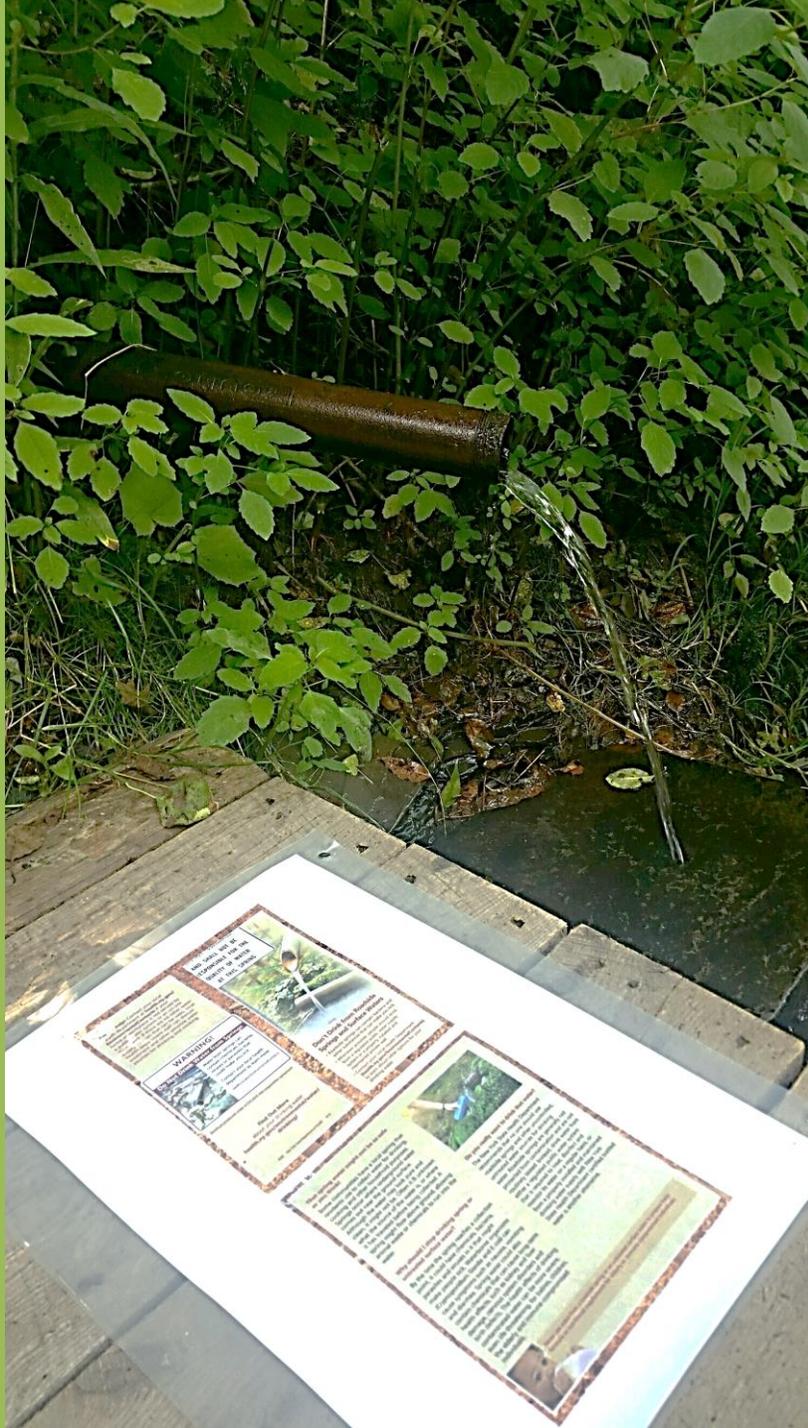
Georgetown Spring

<u>Parameter</u>	<u>Result</u>	<u>Method</u>	<u>Analysis Date/Time</u>
Total Coliform	Positive (Too Numerous To Count)	SM 18-22 9222B	06/21/17 5:05 pm
<i>E. coli</i>	Negative	SM 18-22 9222B	06/21/17 5:05 pm
