**CDC NCEH Environmental Health Services Support
for Public Drinking Water Programs to Reduce
Drinking Water Exposures Grant Project
6/26/18 Presentation to NEHA**

**Reducing Drinking Water Exposures Through
Individual Well Assessments & Outreach**

Madison County Health Department
Environmental Health Division
Madison County, New York

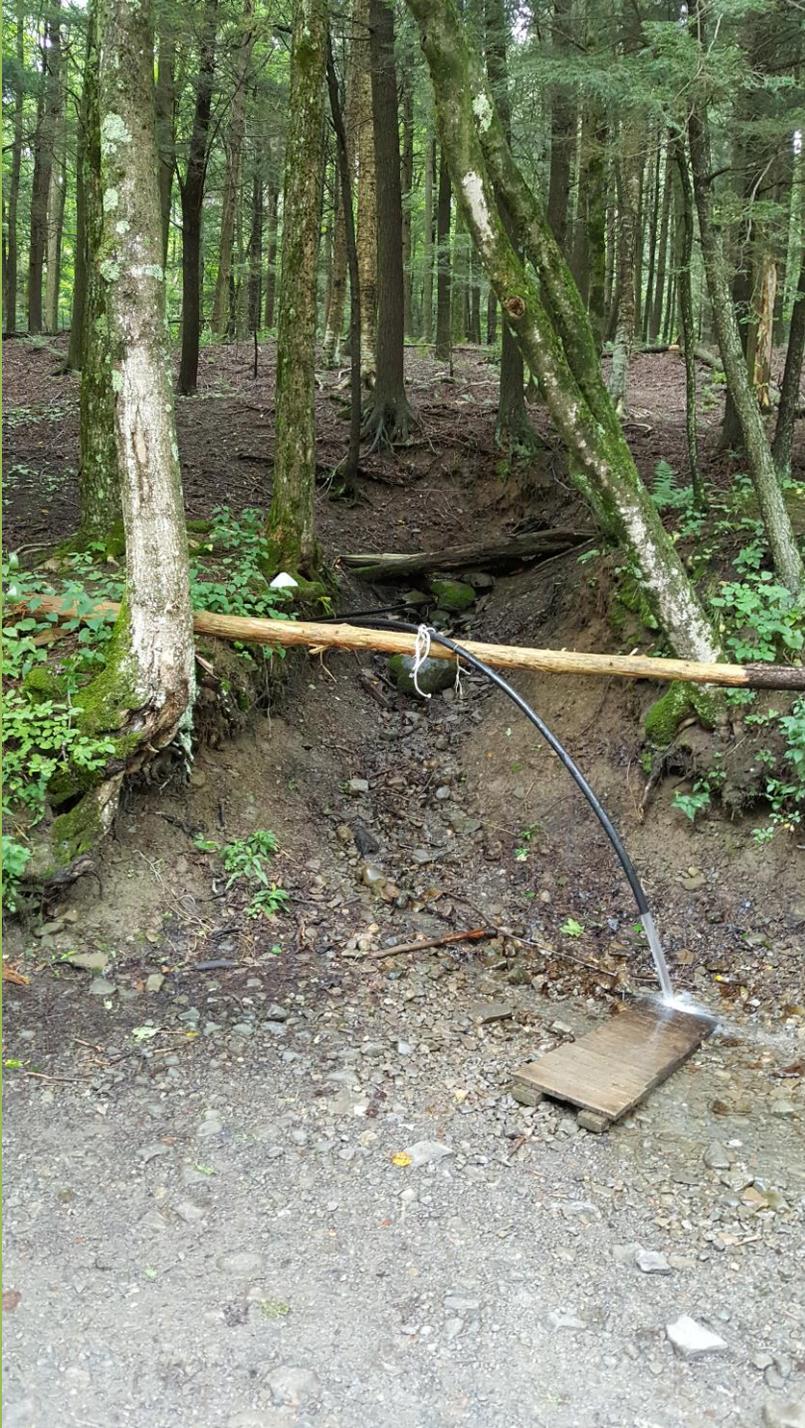
Brookfield Spring

<u>Parameter</u>	<u>Result</u>	<u>Method</u>	<u>Analysis Date/Time</u>
Total Coliform	Positive (48 cfu/100 ml)	SM 18-22 9222B	07/26/17 2:08 pm
E.coli	Negative	SM 18-22 9222B	07/26/17 2:08 pm

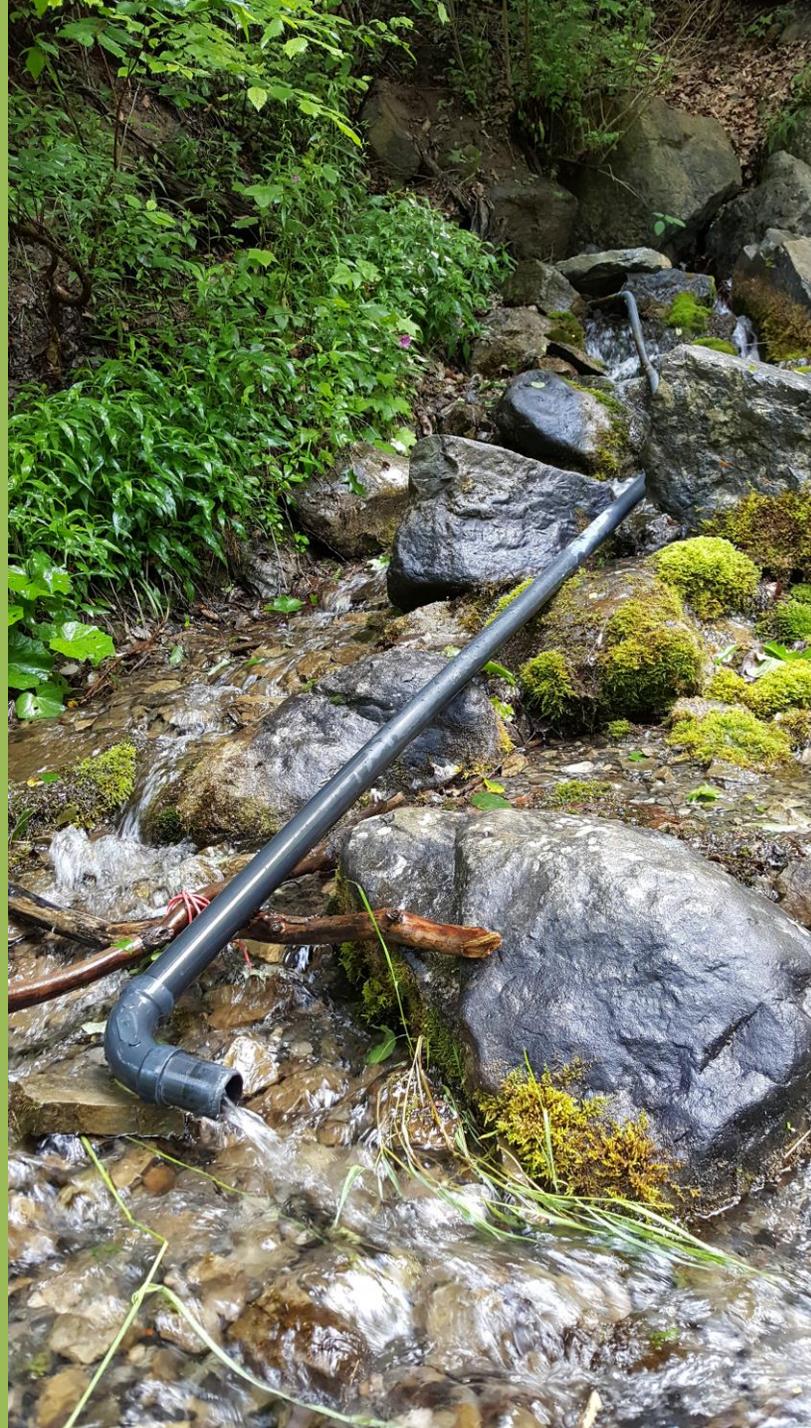
Chittenango Spring

<u>Parameter</u>	<u>Result</u>	<u>Method</u>	<u>Analysis Date/Time</u>
Total Coliform	Positive (Too Numerous To Count)	SM 18-22 9222B	06/27/17 5:12 pm
<i>E.coli</i>	Positive	SM 18-22 9222B	06/27/17 5:12 pm
